ROYAL AEROSPACE ESTABLISHMENT

Technical Report TR 90033

**Sustained-Load Crack Growth of 8090  
Aluminium-Lithium Alloy Plate in Dry  
Air at 50-200°C**

S. P. Lynch

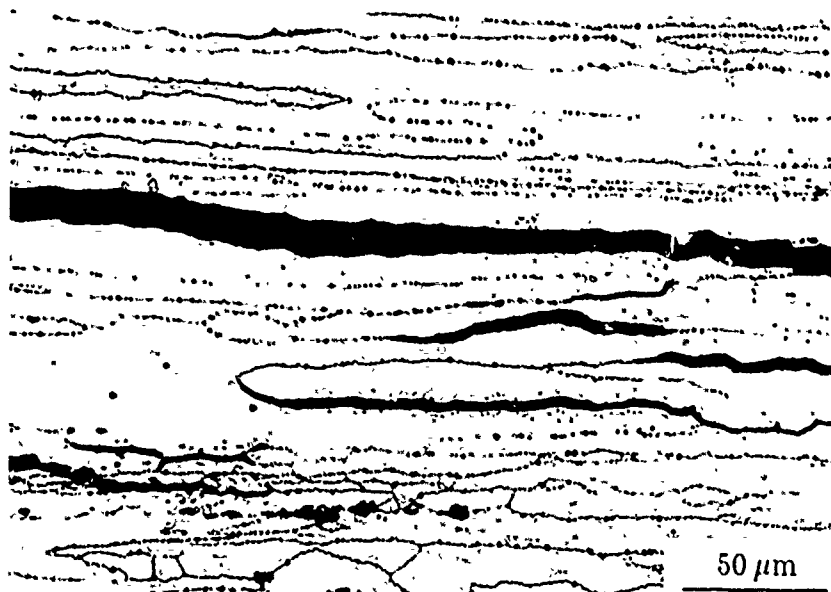
Fig 8 Optical micrograph of section through specimen from the 25mm plate after creep crack growth at 120°C showing multiple, parallel, intergranular cracks

Creep crack growth in Al-Li alloy plates produced multiple, parallel intergranular cracks, particularly at high  $K_I$  values (Fig 8). Fracture surfaces had a 'flaky' appearance (Fig 9) because some grains had been lifted above the general fracture plane due to tearing of uncracked ligaments behind the main crack front. Observations on the side surface of the experimental alloy with ~40 ppm sodium showed that brittle intergranular cracks occurred around inclusions at considerable distances ahead of the main crack tip. Deformation and fracture of ligaments between some of these cracks then occurred (Fig 10).

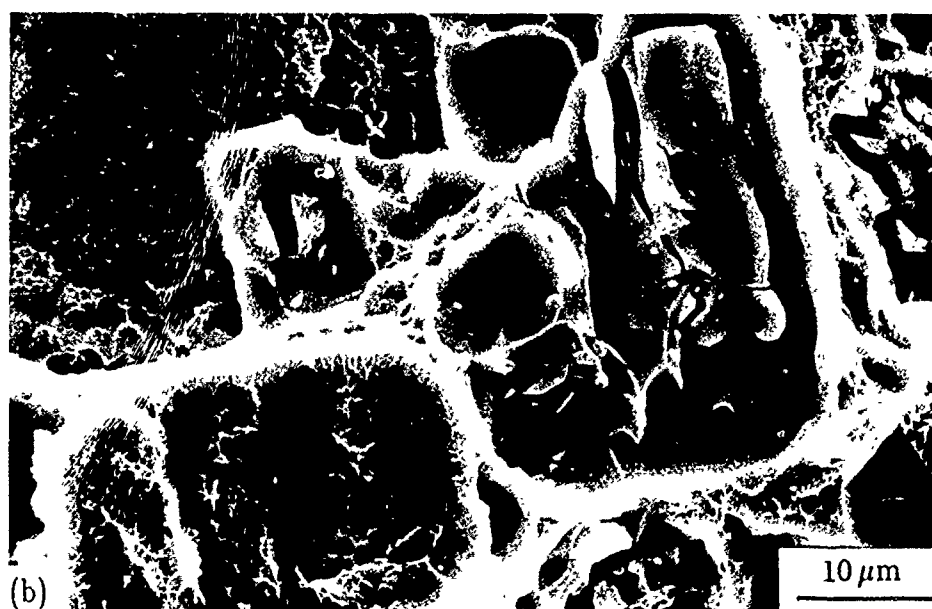
Fig 15 SEM of fracture surface of 2014-T651 plate showing dimples produced (a) by creep cracking of 80°C, and (b) by overload at 20°C

For the 2014-T651 plate, S-L creep crack growth at 80-170°C produced 'brittle' intergranular regions and dimpled areas, but discrete brittle islands were less well defined than those for 8090 alloys; overload fracture of 2014 plate produced well defined dimples on fracture surfaces (Fig 15).
